SUBJECT: Preliminary Assessment Reports for  
Lewis Research Center and Plum Brook Station

POTENTIAL HAZARDOUS WASTE SITE  
PRELIMINARY ASSESSMENT  
PART 1 - SITE INFORMATION AND ASSESSMENT

01 SITE NAME (Legal, common, or descriptive name of site) NASA - Lewis Research Center		02 STREET, ROUTE NO., OR SPECIFIC LOCATION IDENTIFIER 21000 Brookpark Road			
03 CITY Cleveland	04 STATE OH	05 ZIP CODE 44135	06 COUNTY Cuyahoga	07 COUNTY CODE	08 CONG DIST 19
09 COORDINATES LATITUDE 41° 29' 51"		LONGITUDE 81° 41' 50"			
10 DIRECTIONS TO SITE (Starting from nearest public road) Interstate 71 to Brookpark Road west to Lewis Research Center, adjacent to Cleveland Hopkins Airport

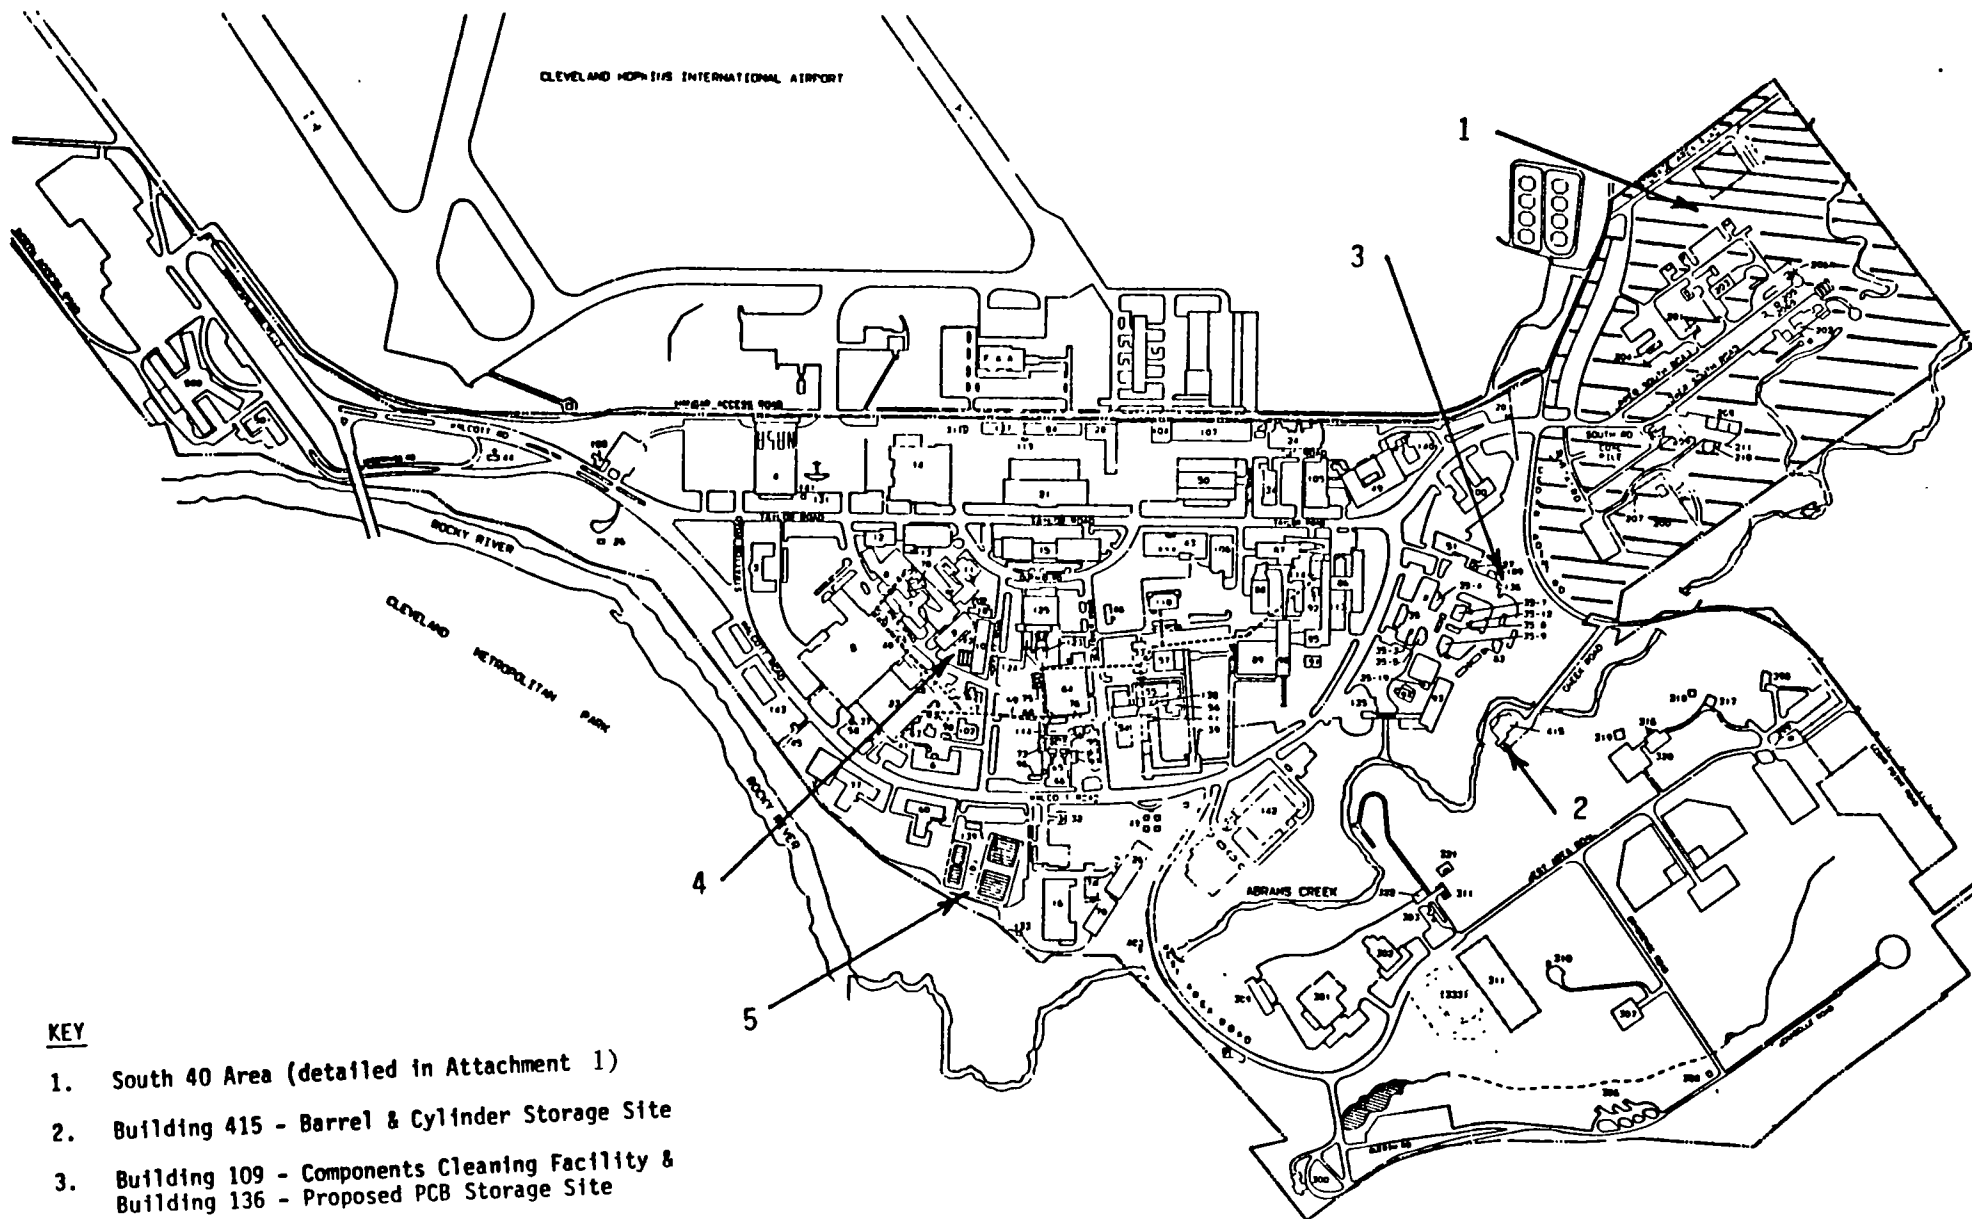
Map of Lewis Research Center  
Showing Areas of Concern

# **KEY**

1. South 40 Area (detailed in Attachment 1)
2. Building 415 - Barrel & Cylinder Storage Site
3. Building 109 - Components Cleaning Facility & Building 136 - Proposed PCB Storage Site
4. Substation E
5. Basins 1, 2 and 3

- Building 415 which is used for storage of hazardous feedstocks as well as hazardous wastes in drums was found to be an area of concern. Drums were found to be outside secondary containment, extremely hazardous materials (hydrazine) was found to be stored next to mixed wastes, the entire facility needs proper containment systems with no monitoring or sampling program. This is an area of great concern which requires immediate attention.

- Buildings 109 and 136 and the areas adjacent to these buildings were found to be a potential contaminant source due to improper storage of hazardous substances and wastes. Several corroded drums were observed stored outside; four diffusion pumps spray painted "MERCURY" were also stored in the area; there were also six drums of mixed hazardous wastes stored outside. None of these items was stored within a secondary containment area which poses a threat from possible leakage contaminating soil and surface and groundwater. This area requires additional investigation.

- Basins 1, 2 and 3 of the industrial waste treatment system appear to have undergone recent renovation including sealing cracks. There is no monitoring or sampling done adjacent to the basins to assure they are not impacting the environment.

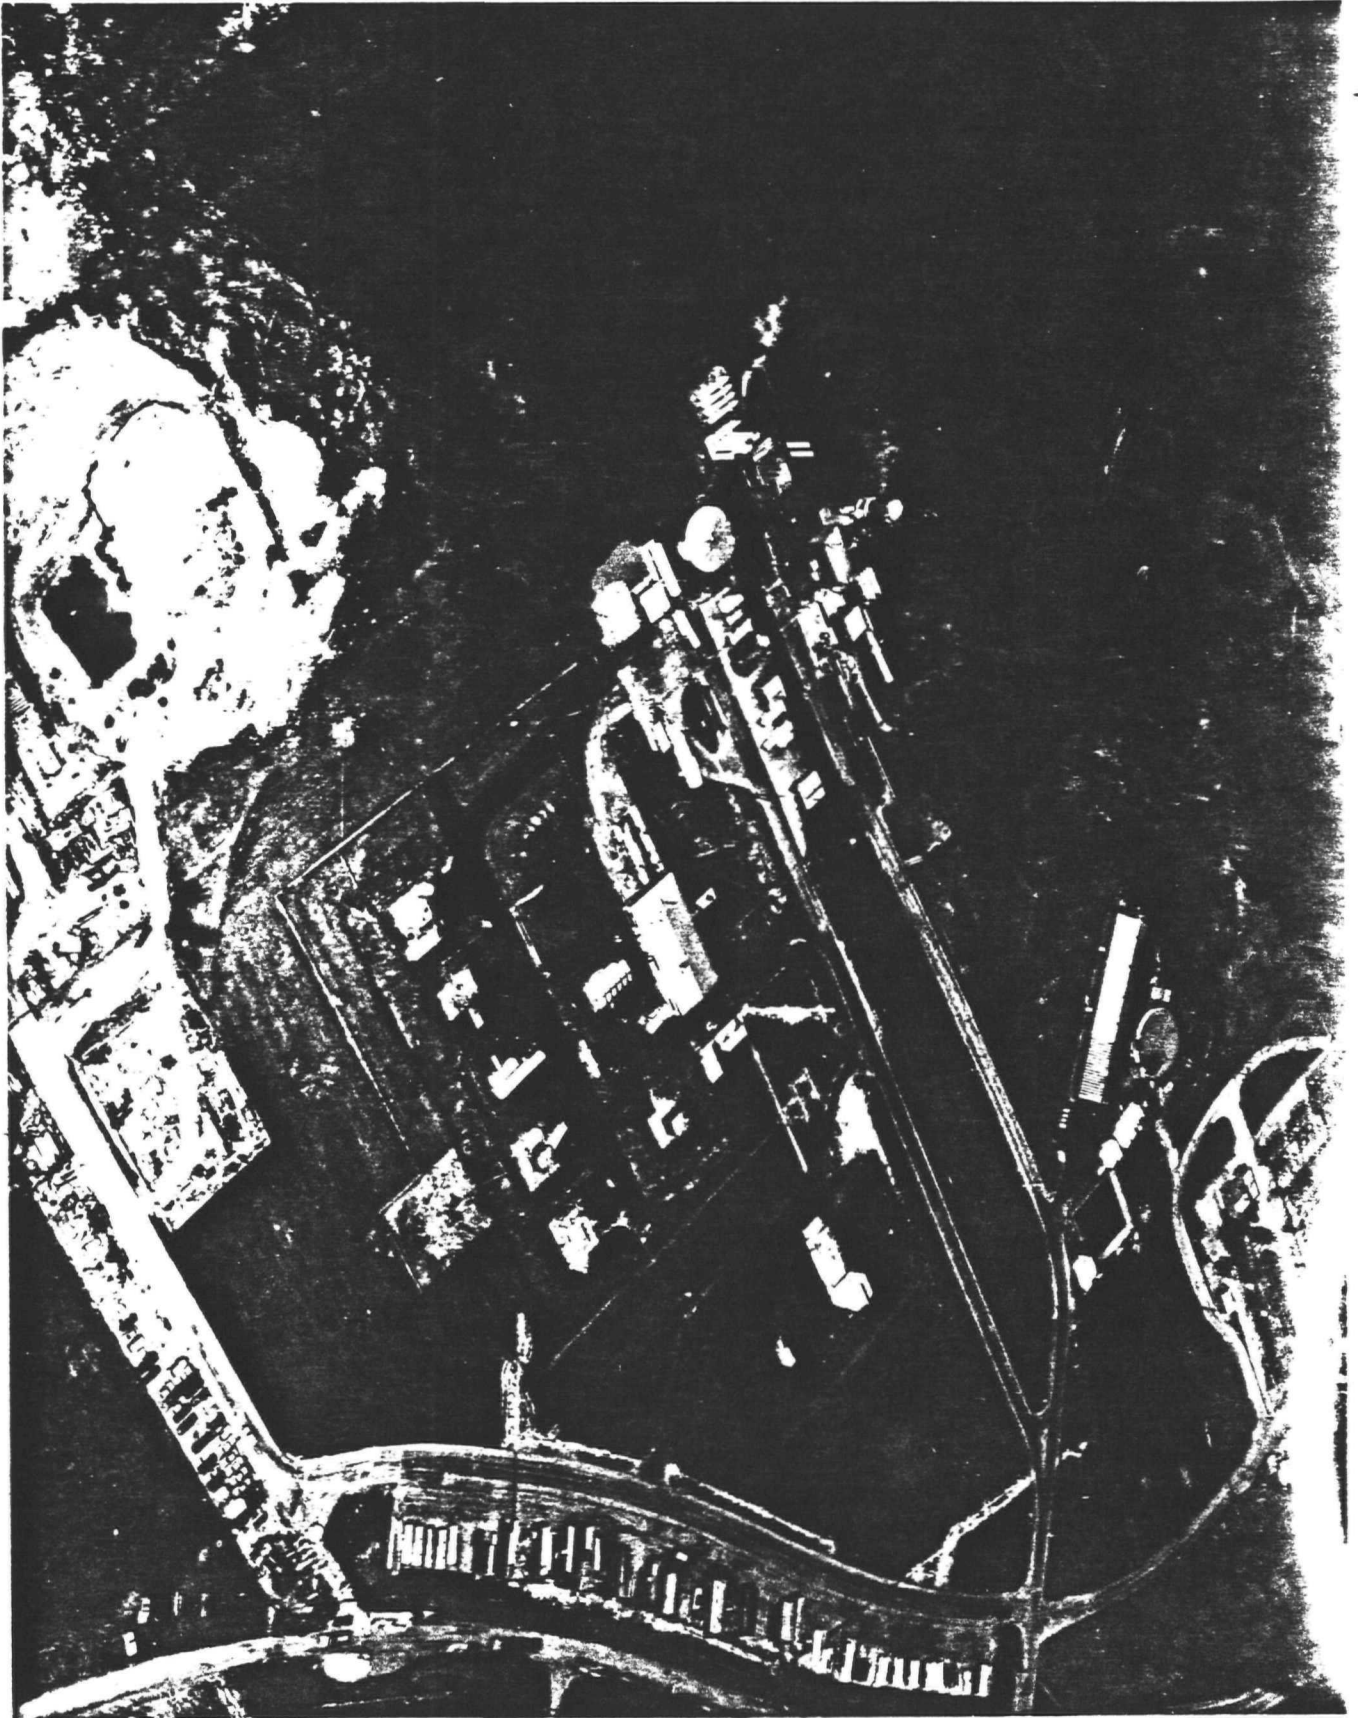
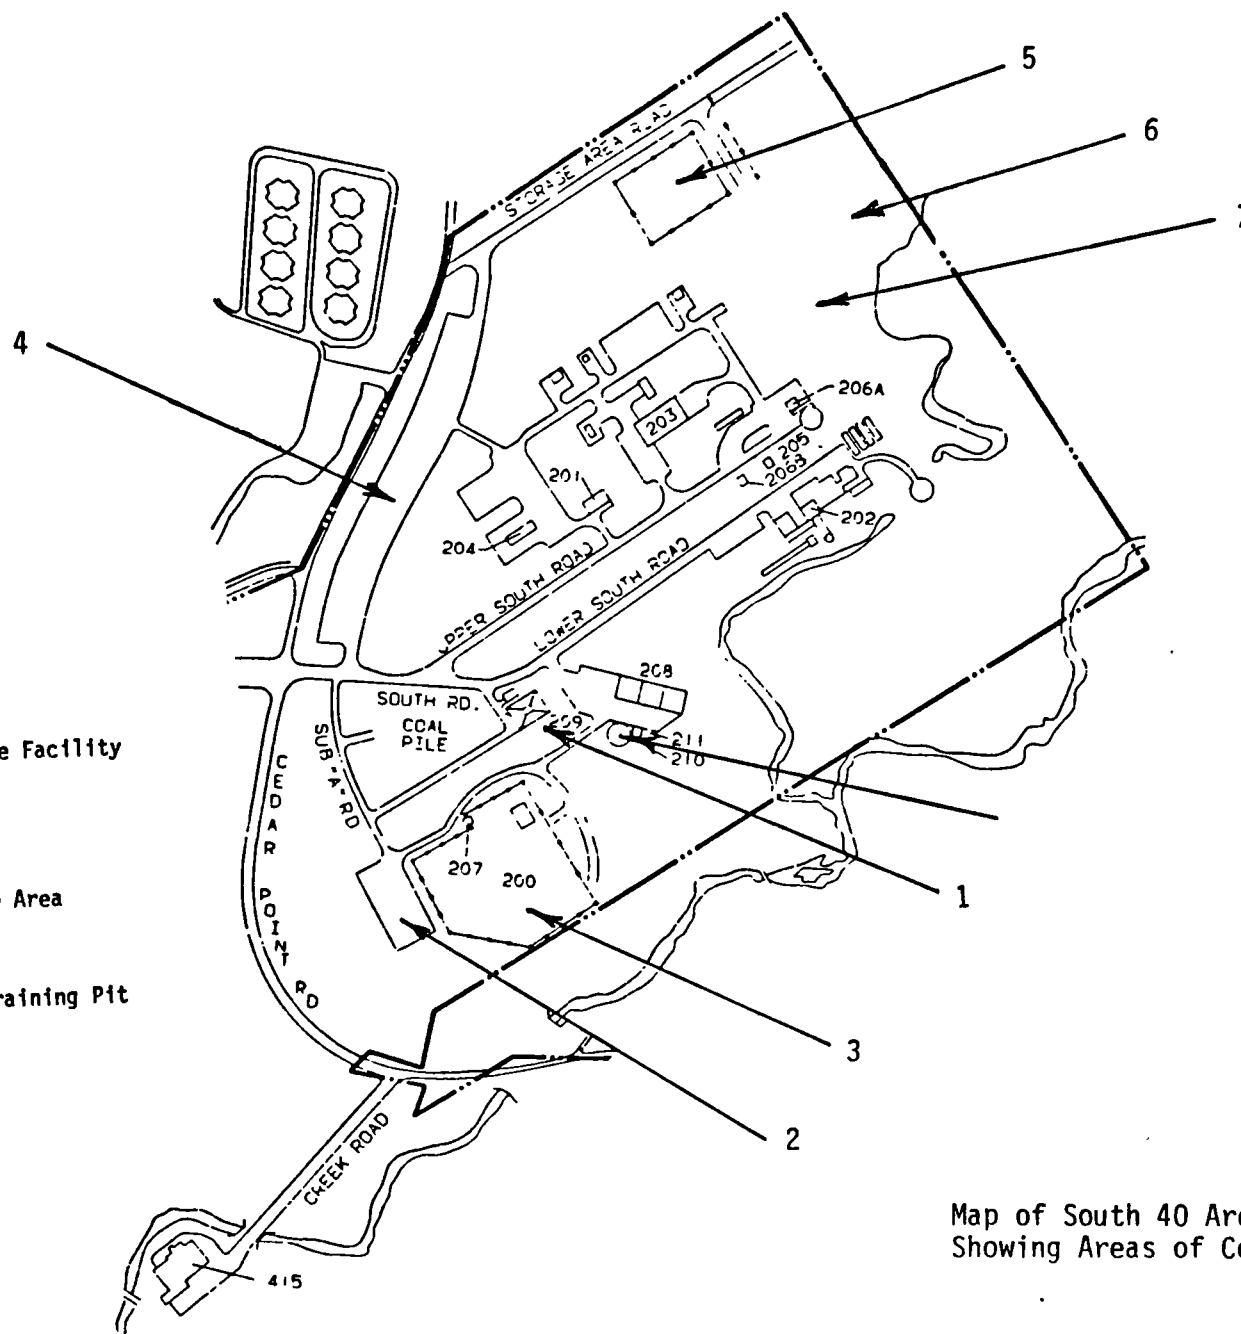
Map of South 40 Area  
Showing Areas of Concern

KEY

1. Building 209 - Coal Storage Facility
2. Salvage Area 1
3. Substation A
4. Contractor Trailer Storage Area
5. Salvage Area 2
6. Location of Former Fire Training Pit
7. Landfill Area

- Fire Training Pit was found to be no longer present on the landfill although it was observed in a photograph of South 40 taken in 1987 (see Attachment 2). There is no record of what was done to close and

1. Building 209 - Drums stacked on their sides next to fence (also in scrap yard), batteries on ground next to fence.
2. Contractor Trailer Storage Area - Drums labelled "corrosive" and "zinc chloride" are stored on ground, some on their sides.

8. Basins 1, 2 and 3 - Evidence of cracking in basins (sealed).
9. Substation A - Evidence of PCBs in concentration greater than 500 ppm leaking from 5200 gallon capacity transformer. Observed discolored gravel on ground from transformer dripping PCBs.
